STRUCTURAL INSPECTIONREPORT

**“Harold Fisher & Sons” Abandoned Building
200 Ash Street
Delanco, New Jersey 08075**

September9, 2020

Prepared by:
**Harry R. Fox
Environmental Resolutions, Inc.
815 East Gate Drive Road, Suite 103
Mount Laurel, New Jersey 08054**

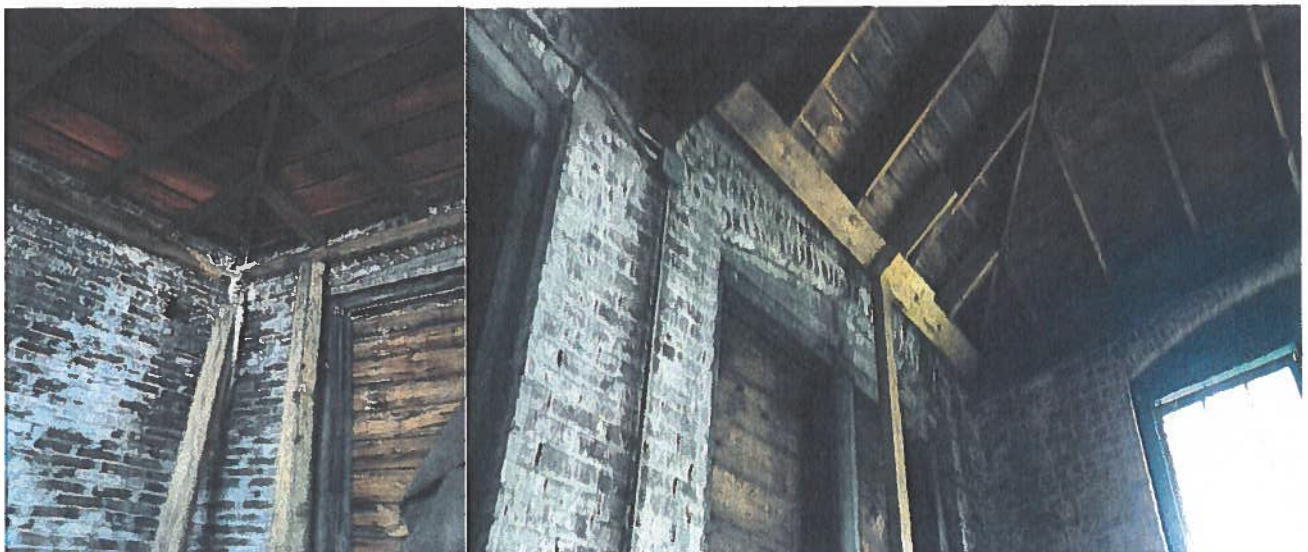
There is roof damage at the Northwest corner which caused some damage and rot of the wood planking, and rafters. It appears that the damage is concentrated in the northwest corner and was previously repaired and supported. Should the building be repaired for permanent occupancy, further analysis of the repairs should be performed. The current condition of the roof would not be of concern with respect to an immediate hazard.

Rotted roof planks and rafters

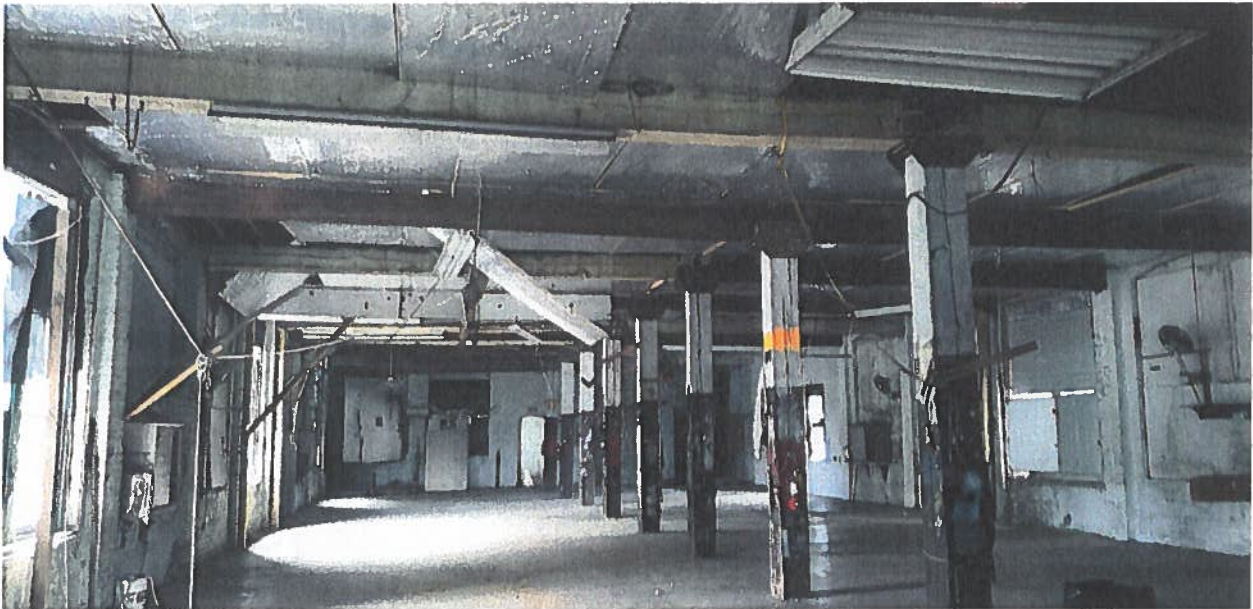
The building contains one (1) row of 12"x12" support columns down the center which supports the first and second floors. The columns show signs of failure probably caused by live loads (material storage) placed on the respective floors. The damaged columns should be repaired or replaced if permanent occupancy is considered.

Center wood columns with cracks

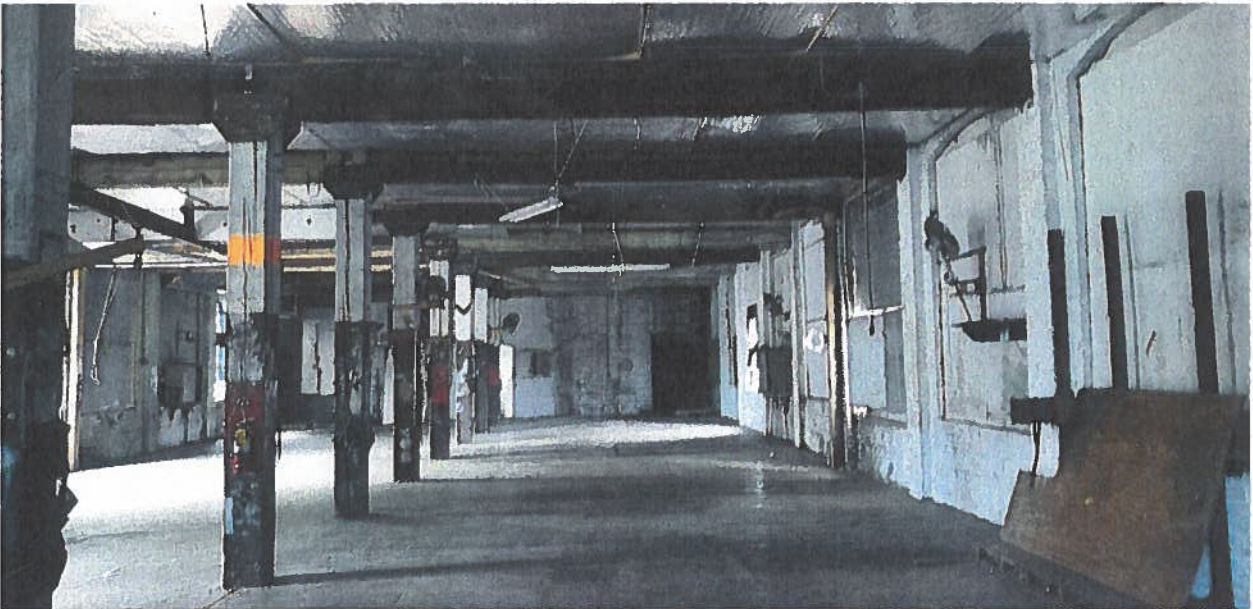
Center wood columns with cracks

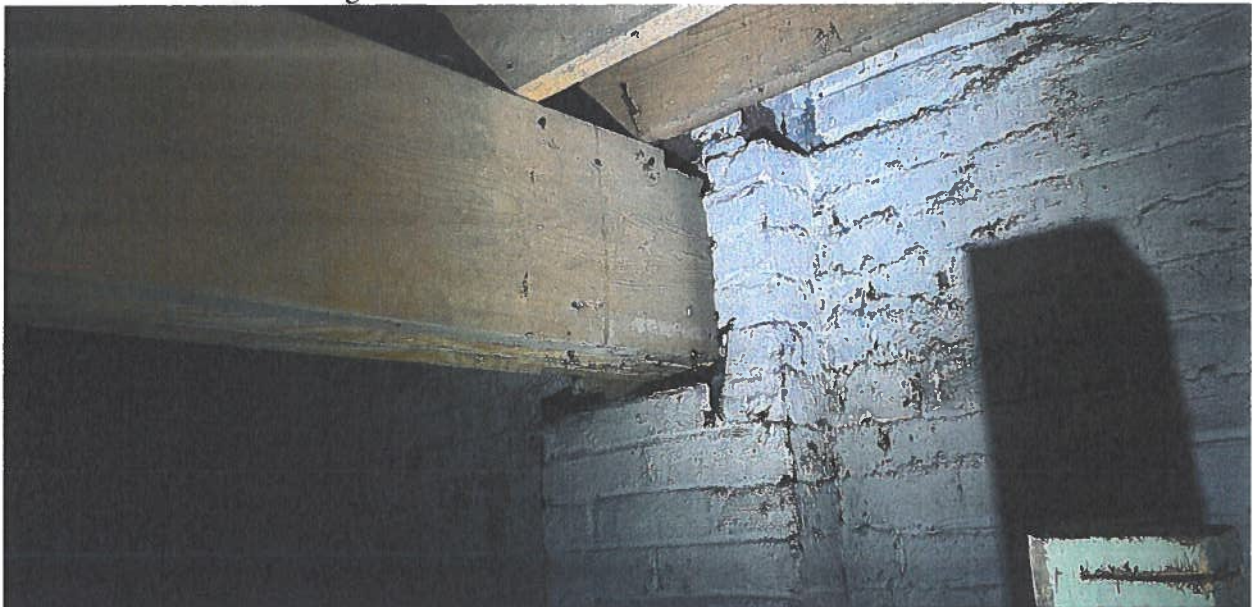
Brick column with prior repairs

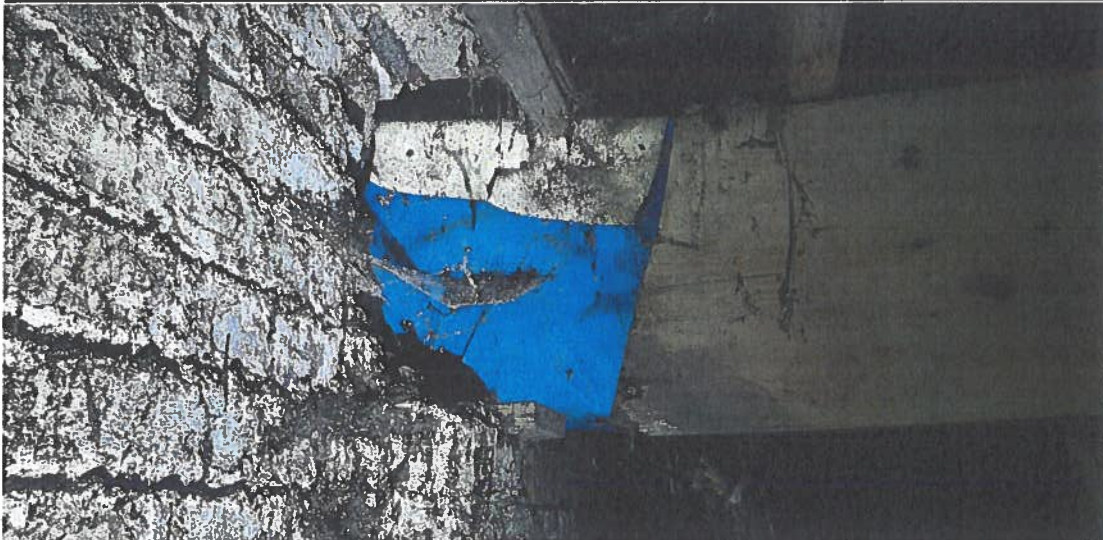
The structure has 12"x12" wood beams spaced at 10 intervals that are supported by the center columns and brick columns located on the exterior walls. Certain brick columns show signs of failure mostly caused by rotted beam supports at each floor. The brick columns should be repaired if the structure is to remain standing.

Brick column and rotted beam

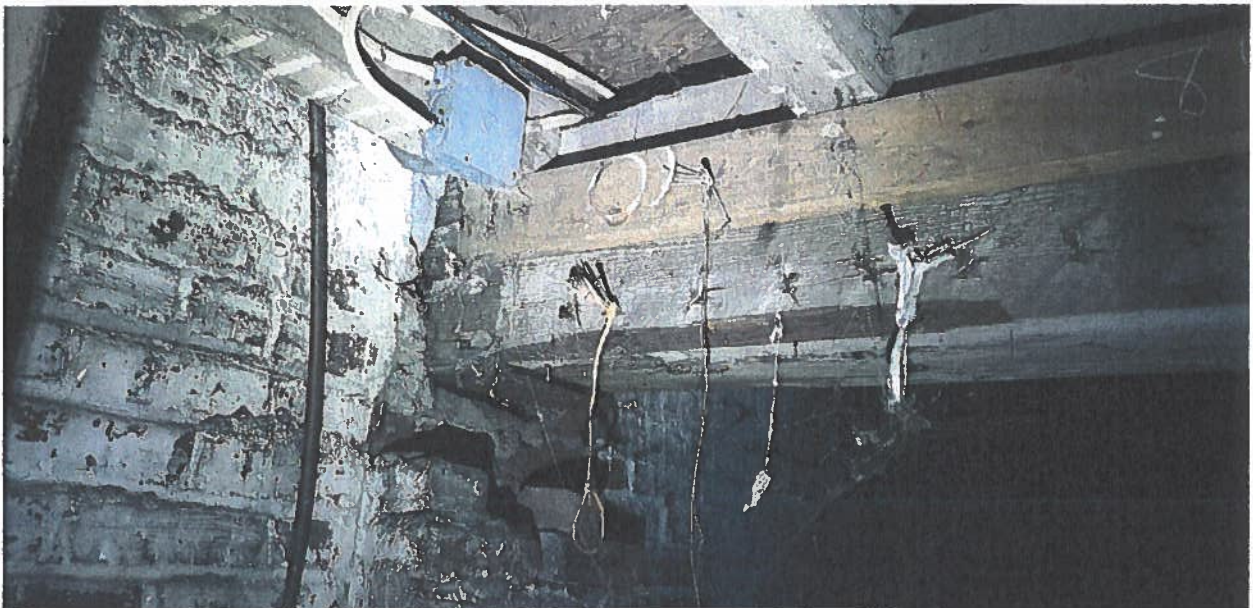
Brick column failing

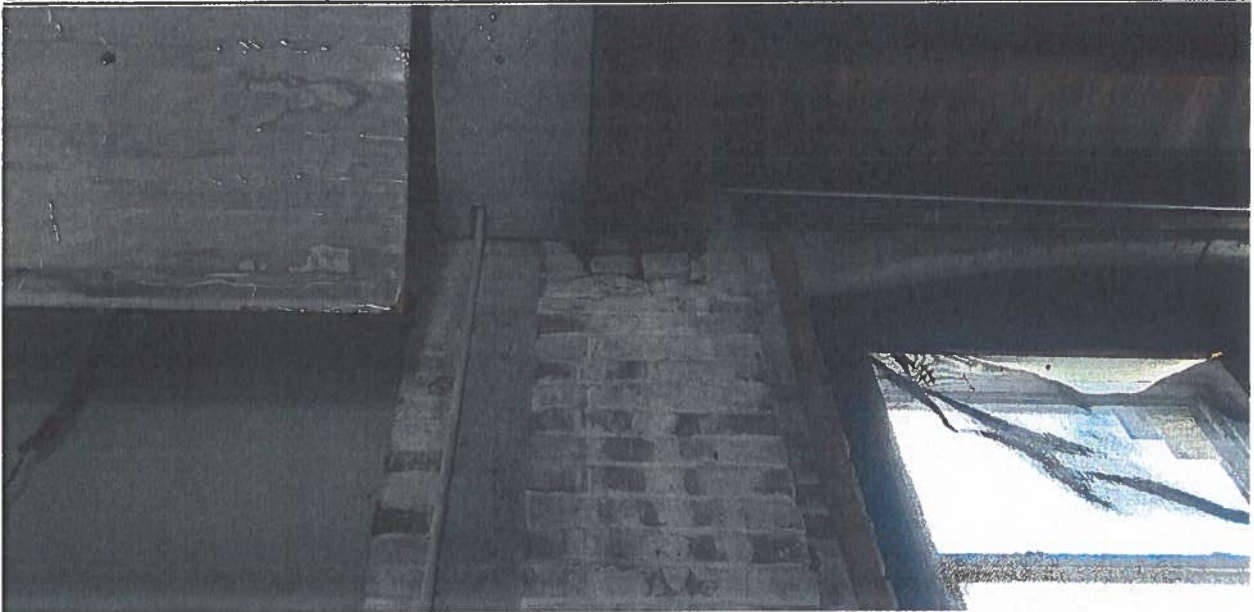
Brick column failing

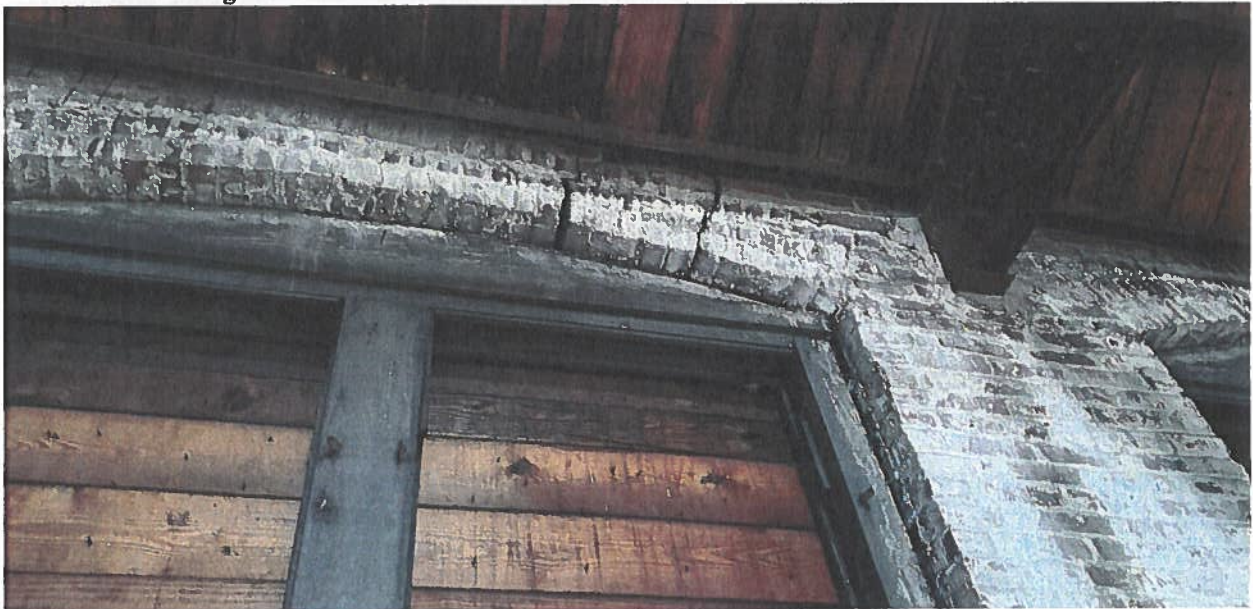
The brick window arches show signs of failing at numerous locations. The probable causes of the failures are poor construction techniques and the failing columns. The arches should be repaired if the structure is to remain standing.

Brick arch failing

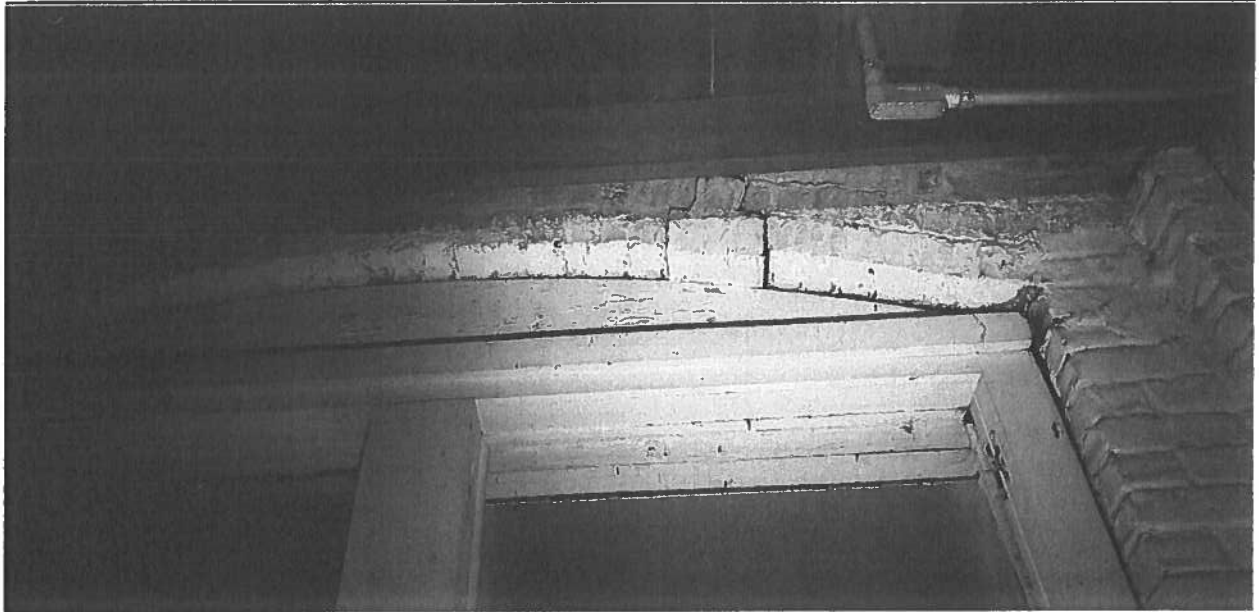
Brick arch failing

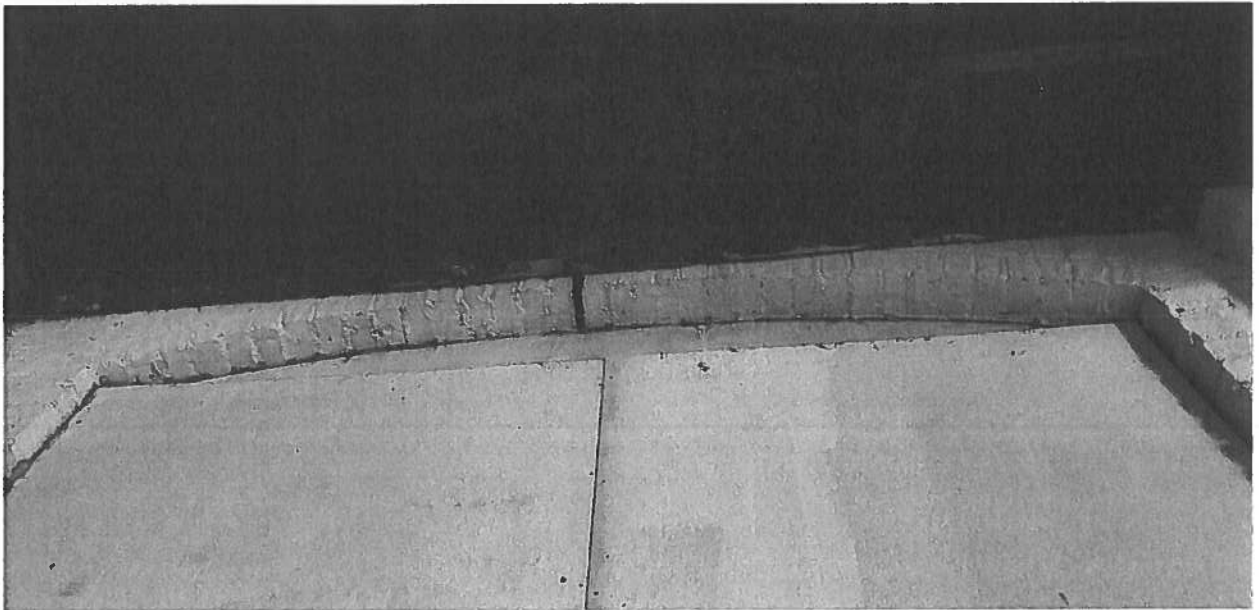
Brick arch failing

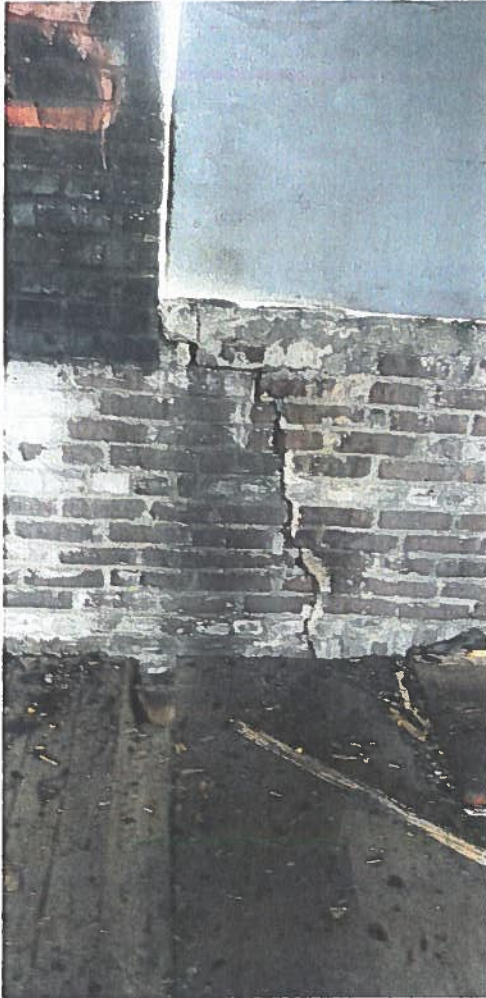
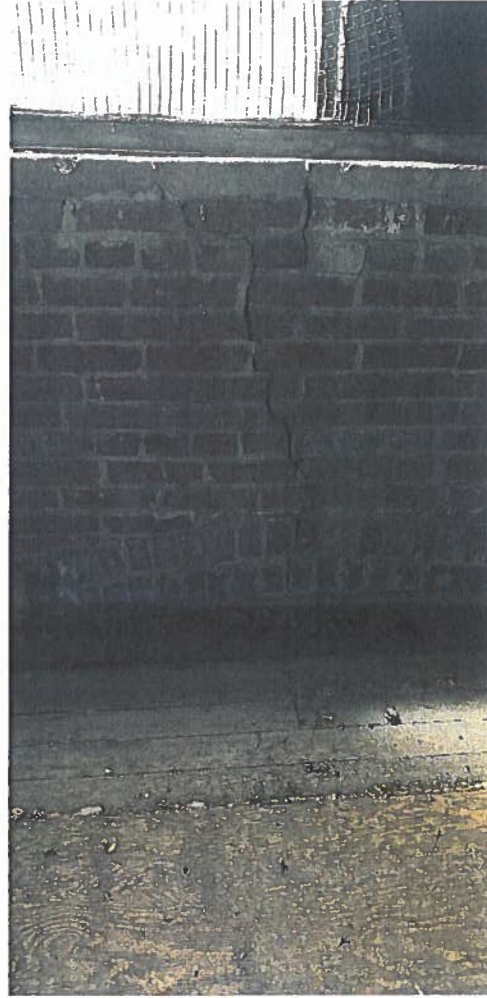
The exterior walls have significant settlement cracks caused by poor construction techniques and failing beams and columns. The exterior walls show no sign of bowing, therefore, at this time, there is no indication that an immediate collapse is pending. The exterior brick walls should be repaired if the structure is to remain standing.

Exterior brick wall failure

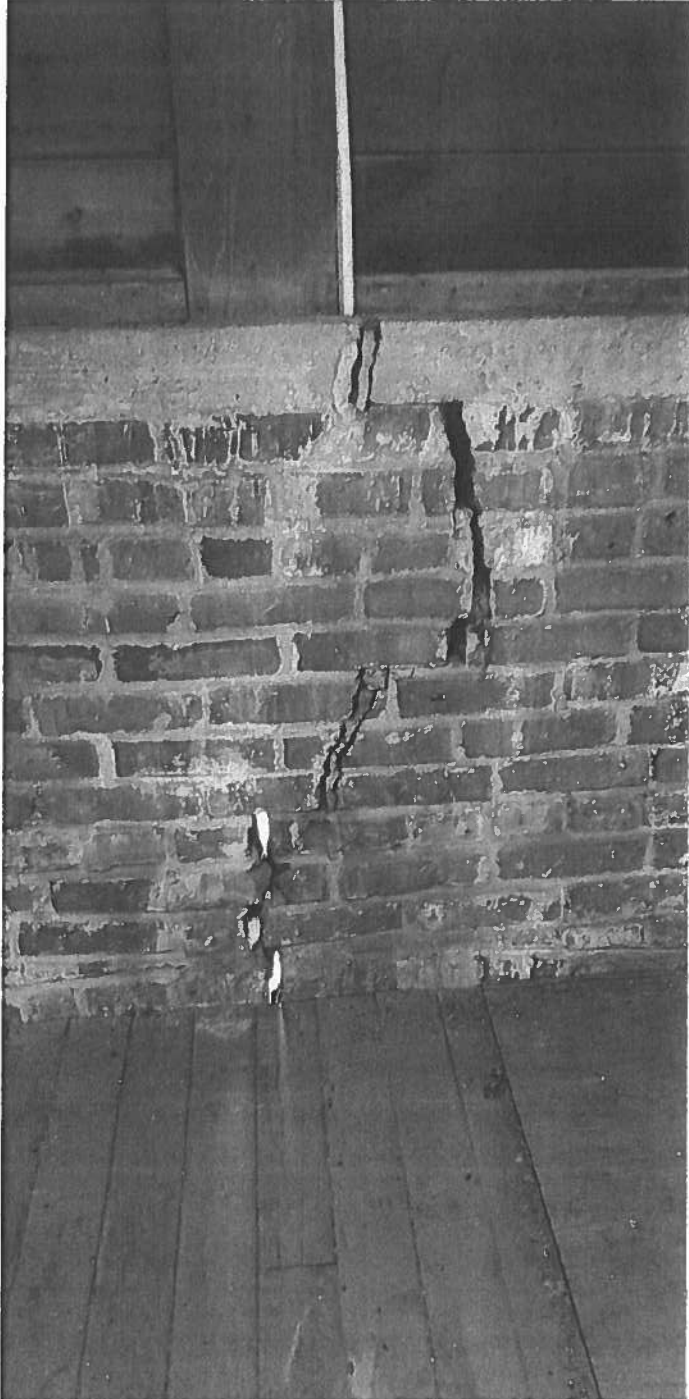
Exterior brick wall failure

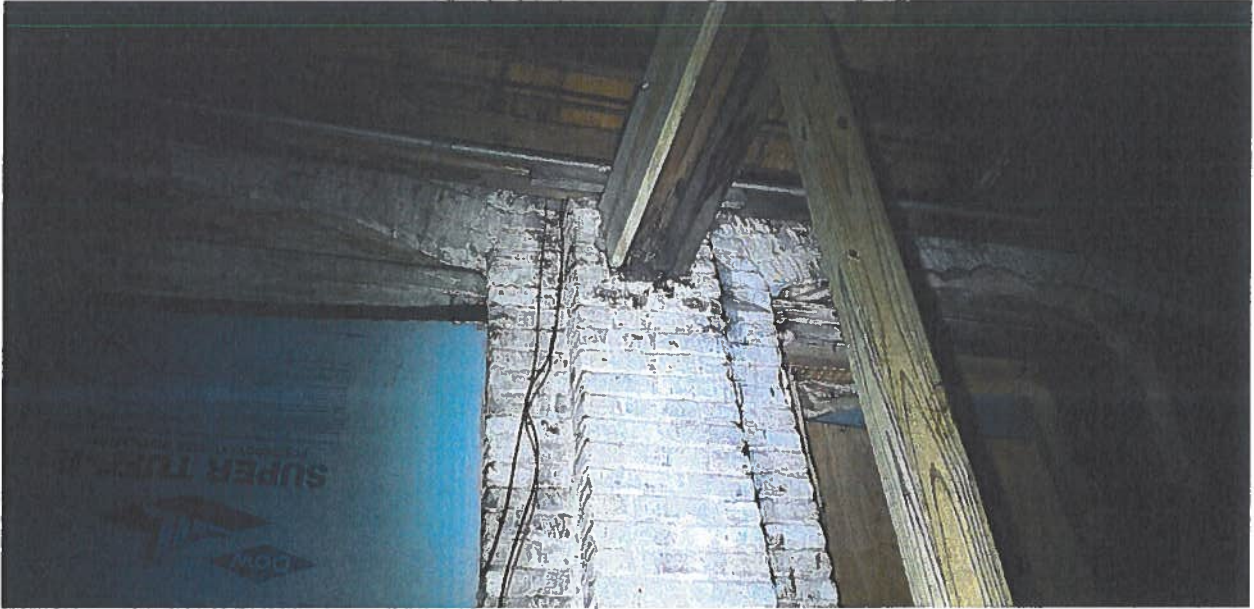
There are several locations where repairs have been made to the structure over time. These repairs should be further analyzed for acceptance prior to permanent occupancy. All repairs should be made in accordance with standard building practices.

Previous repairs

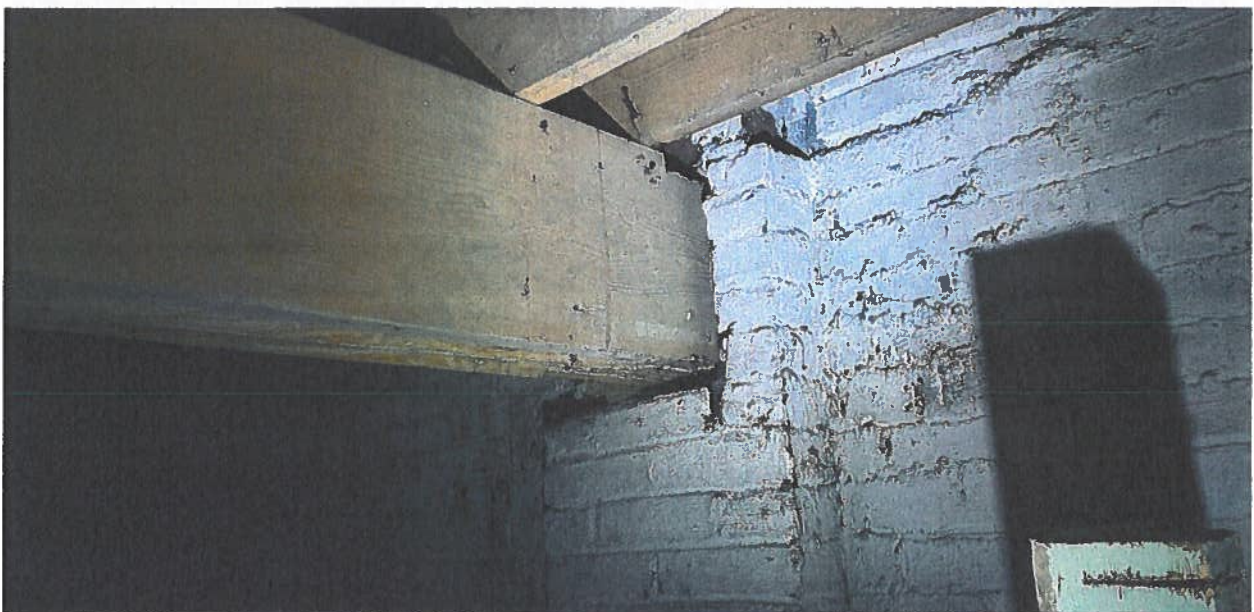
Previous repairs

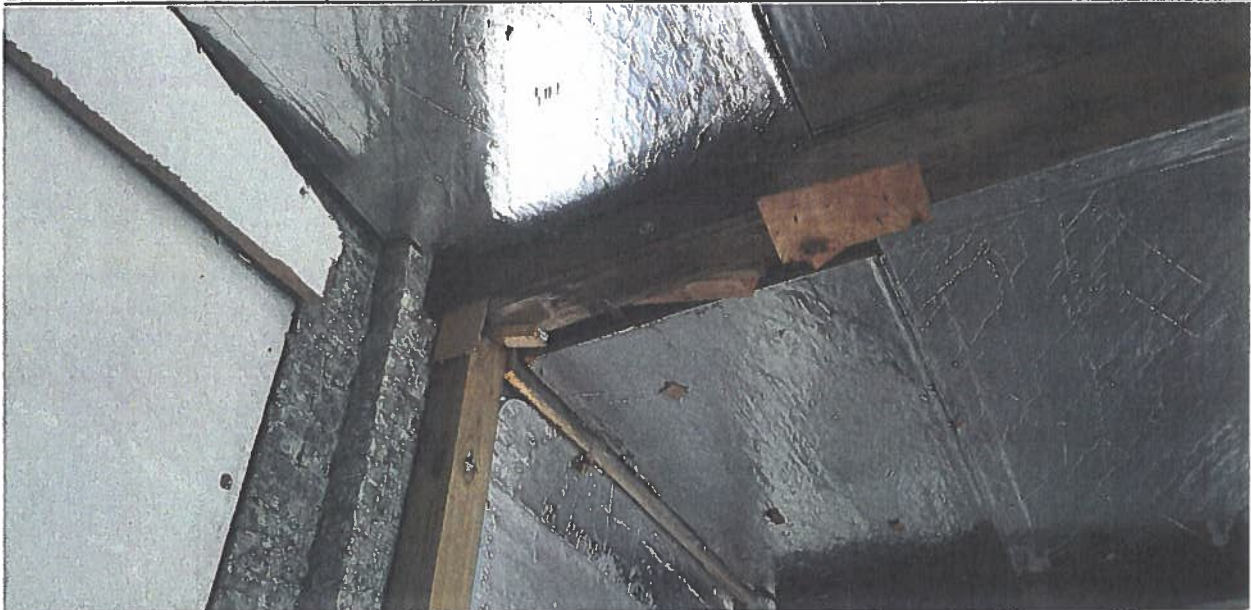
Previous repairs

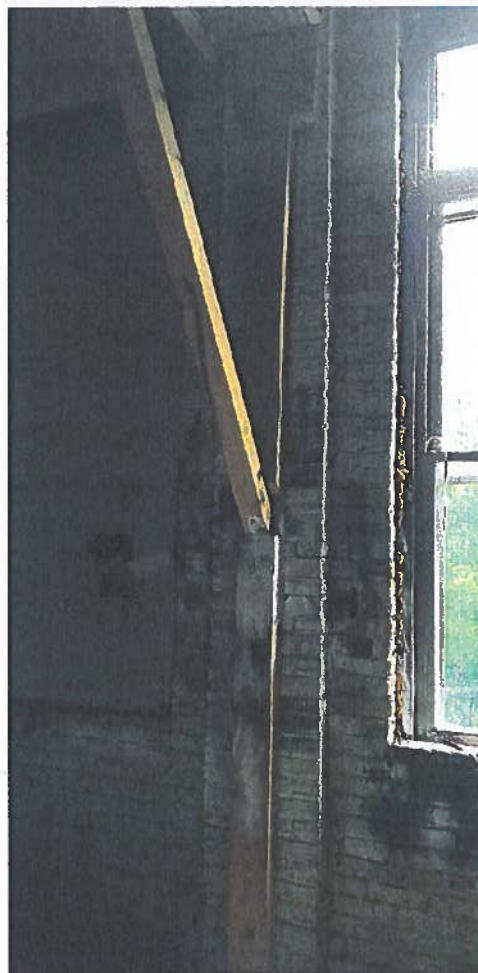
Previous repairs

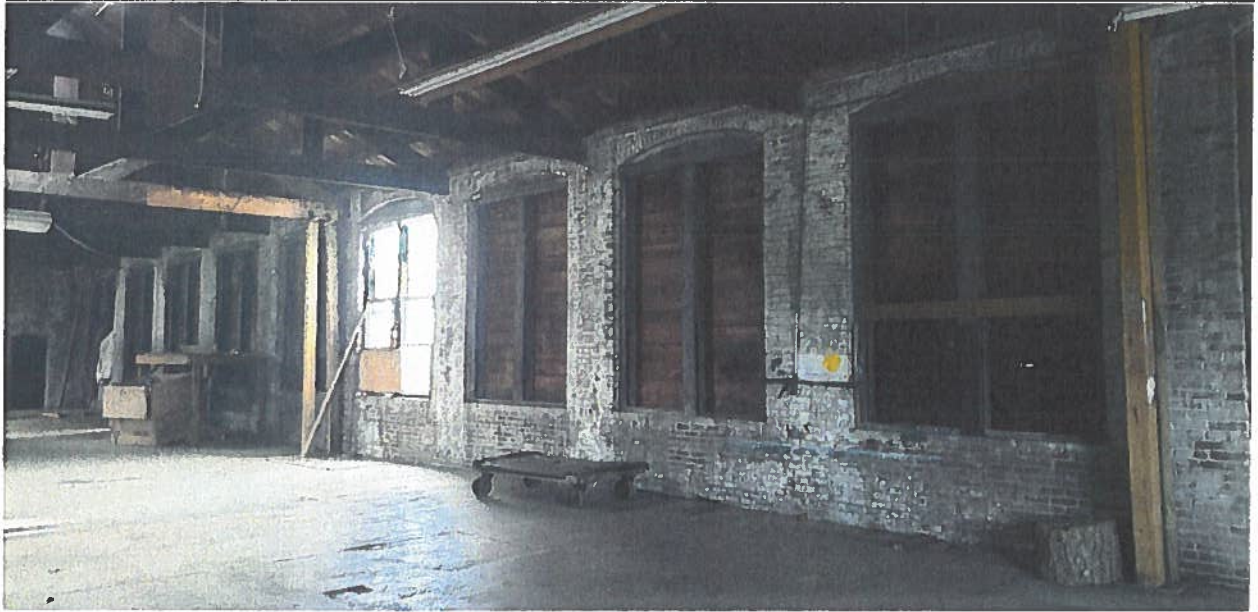
Previous repairs

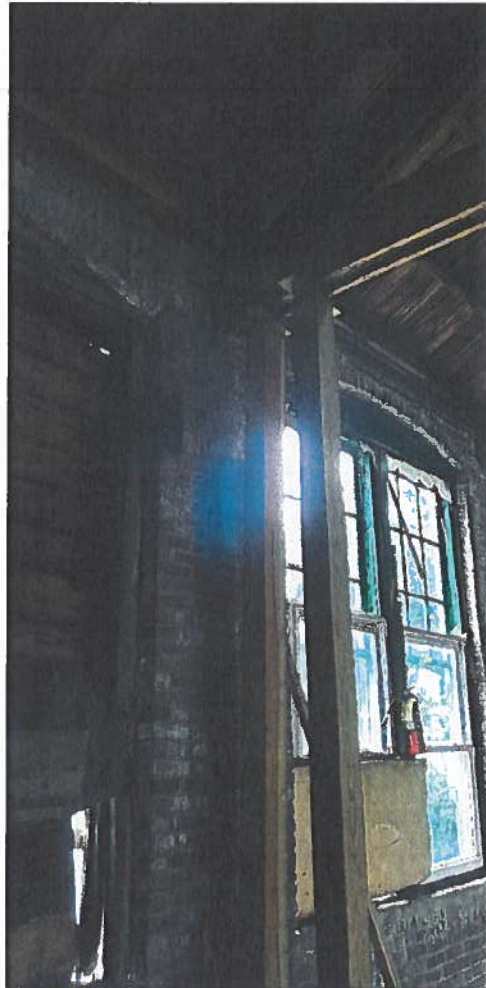
Previous repairs

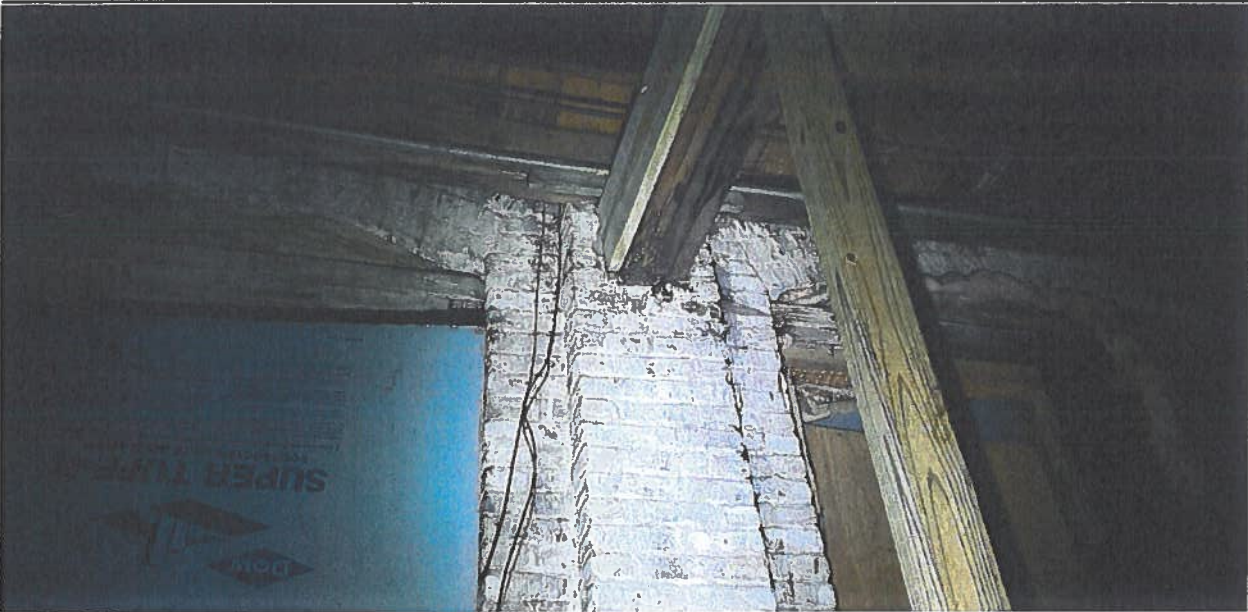
Previous repairs

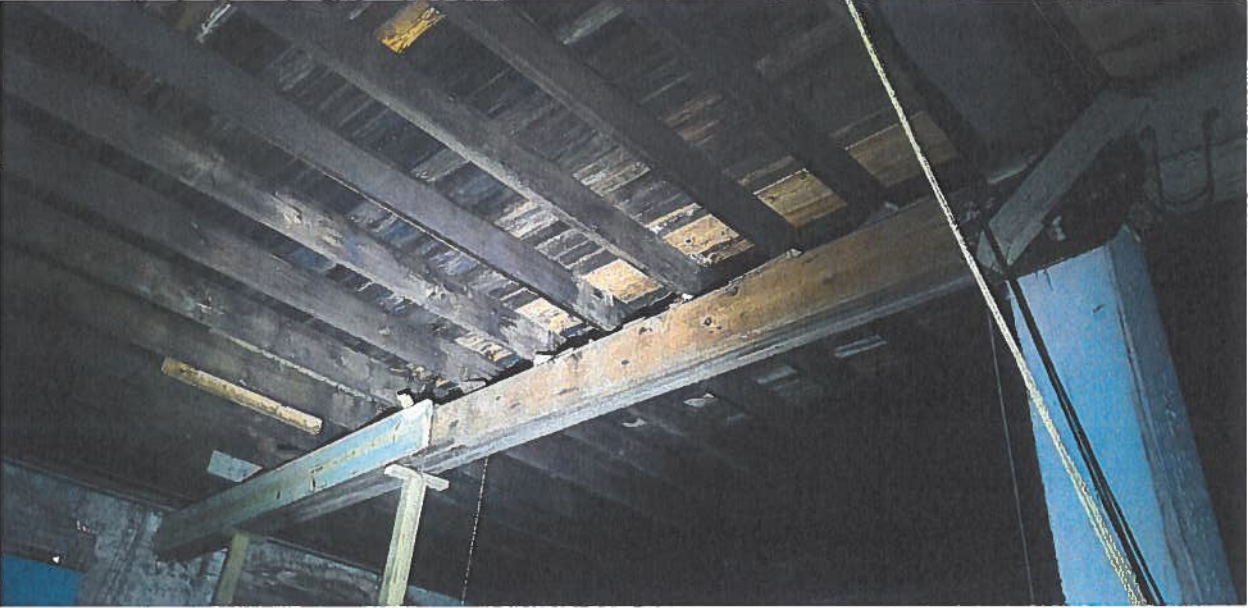
Previous repairs
