Preliminary Investigation

*Non- Condemnation Area in Need of Redevelopment, or
Area in Need of Rehabilitation*

Block 1405; Lots 1, and 6
Block 1411; Lots 1, 1.01, and 2

Delanco Township , New Jersey

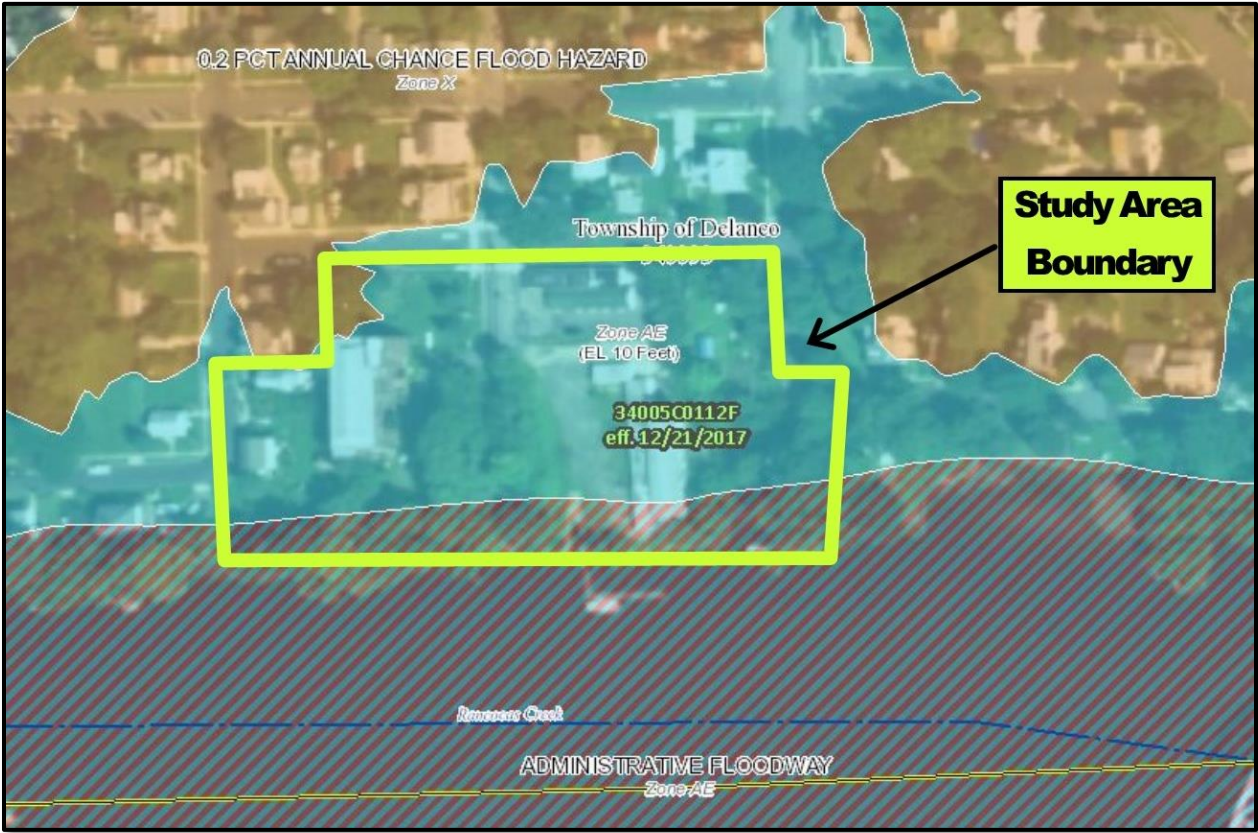
Flood Mapping

The map below illustrates the Regulatory Floodway as the hatched area closest to the waterway; the blue is in the AE Zone – an area inundated by 1% annual chance of flooding (100 year flood) with a required residential base flood elevation set to 10'; and the tan is Zone X – an area with 0.2% annual chance of flooding (500- year flood). Source: FEMA FIRMette.

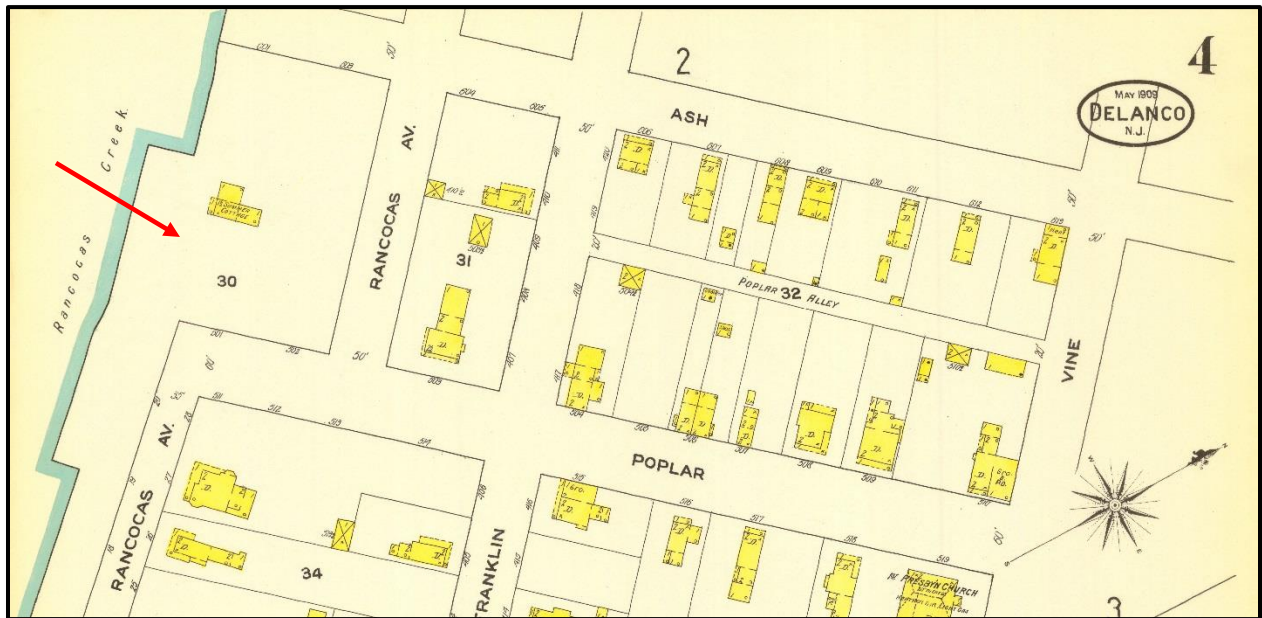
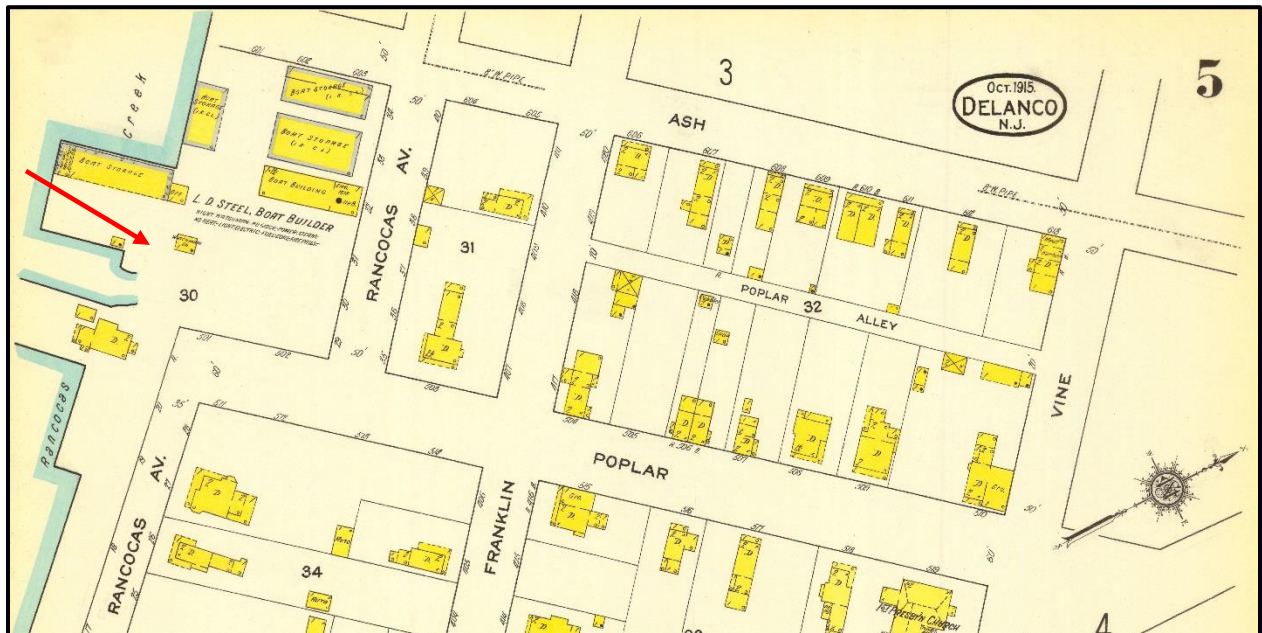
The following two Sanborn maps from 1909 and 1915 illustrate the evolution of building development upon Block 1411 (see #30).

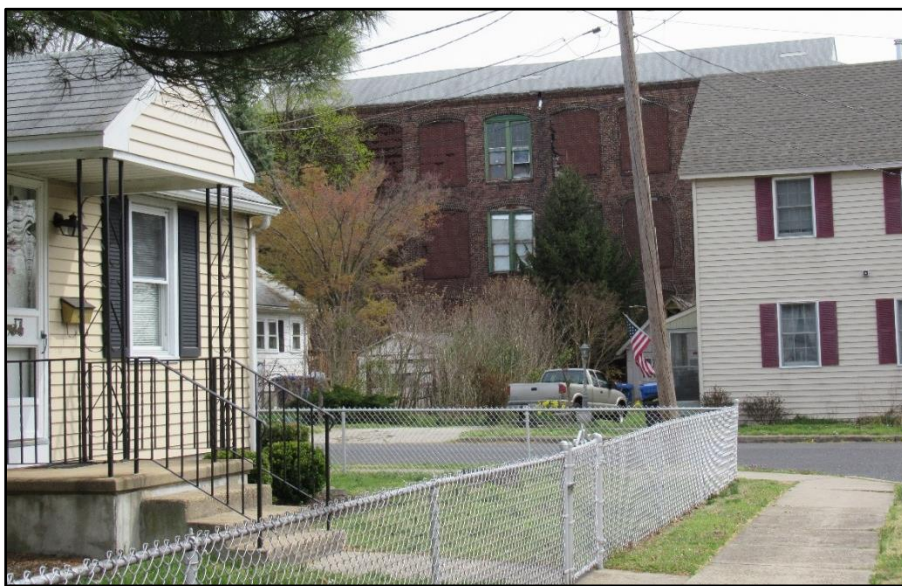
Currently, Block 1405, Lot 1 contains an occupied residential dwelling and a few of small sheds in the rear yard, which are likely remnants of the fishing shacks used by fishermen. The dwelling (partially shown at lower right) and property are well-maintained, similar to the other dwellings on Buttonwood Street, as illustrated below:

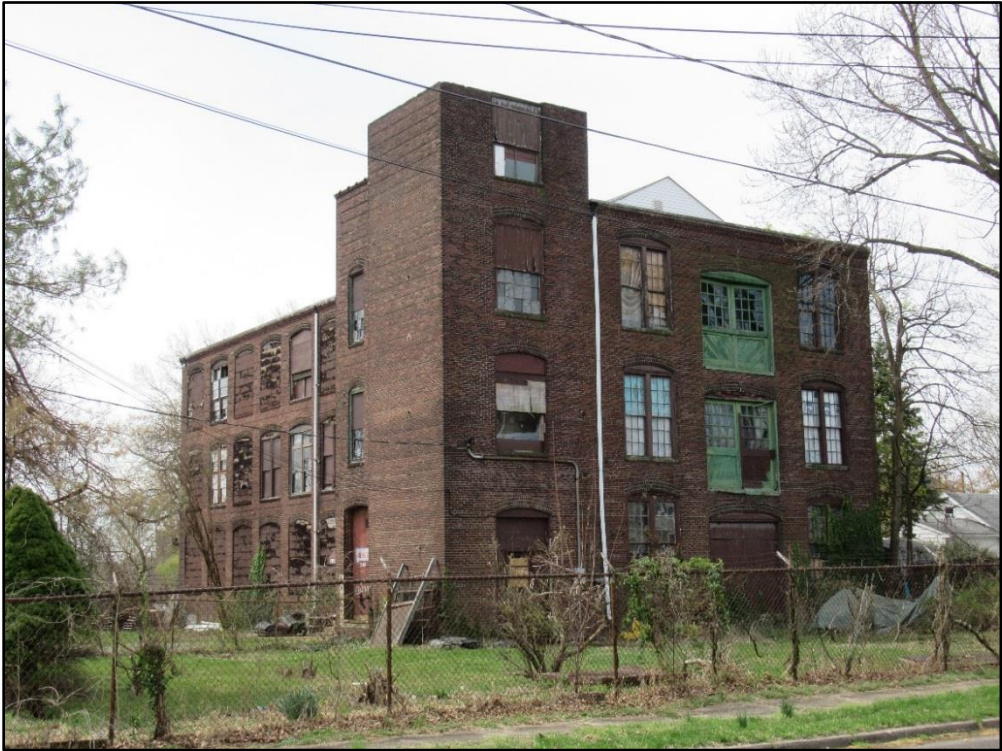
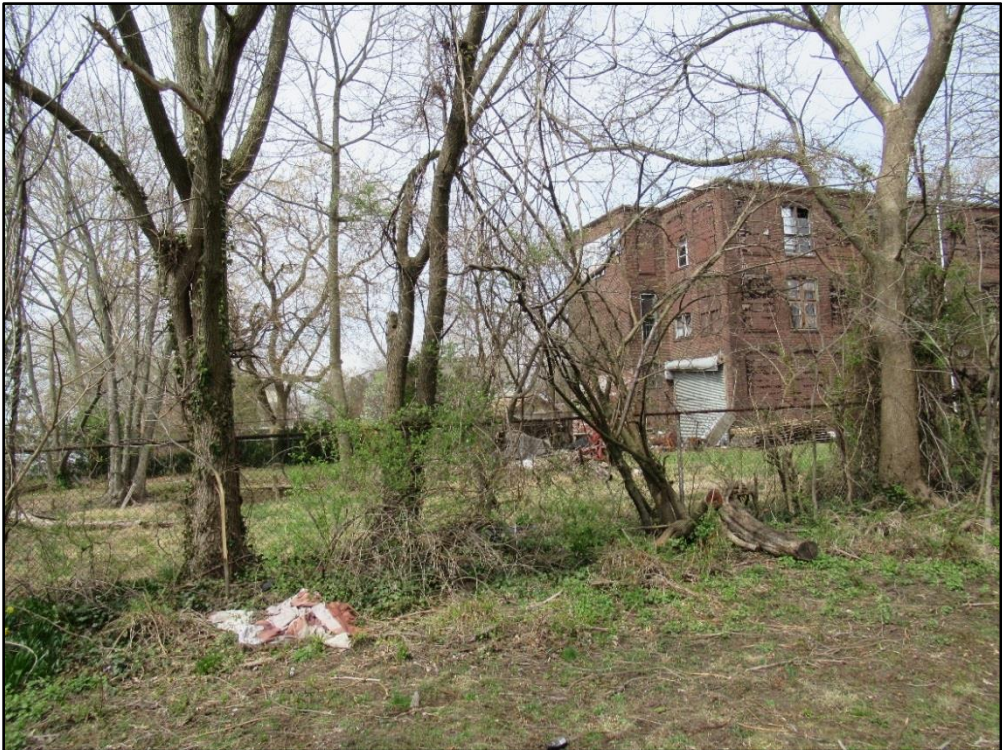
See images below of the site and building located on Lot 6. The first image is taken from Rancocas Avenue facing southeast; and the second is taken from the Ash Street unimproved street-end along the Rancocas Creek facing west.

On November 28th, 2018 Harold F. Fisher & Sons Inc. was issued a “Notice of Unsafe Structure”. A report by a civil engineer indicates the building is sound in structure, however, that there were several temporary support braces that should be replaced with permanent repairs. Violations found concerning the code and safety of the structure include exposed electrical boxes, lack of fire extinguishers, no emergency lighting at exits or stairways inside or outside, and fueled equipment inside building. The means of egress was found unsafe and inoperable, and a freight elevator was found inoperable.

The building known as the Canvas Shop on Block 1405, Lot 6 is consistent with 40A:12A-5.a., for dilapidation and obsolescence of the structure where it was inspected and found not to be code compliant and requiring maintenance. The structure was constructed in 1912 and used for manufacturing of products. The building was purchased in 1960 through a tax sale due to delinquency. There is a concern that the continued disuse of the building could be conducive to unwholesome working conditions within the building and the site.

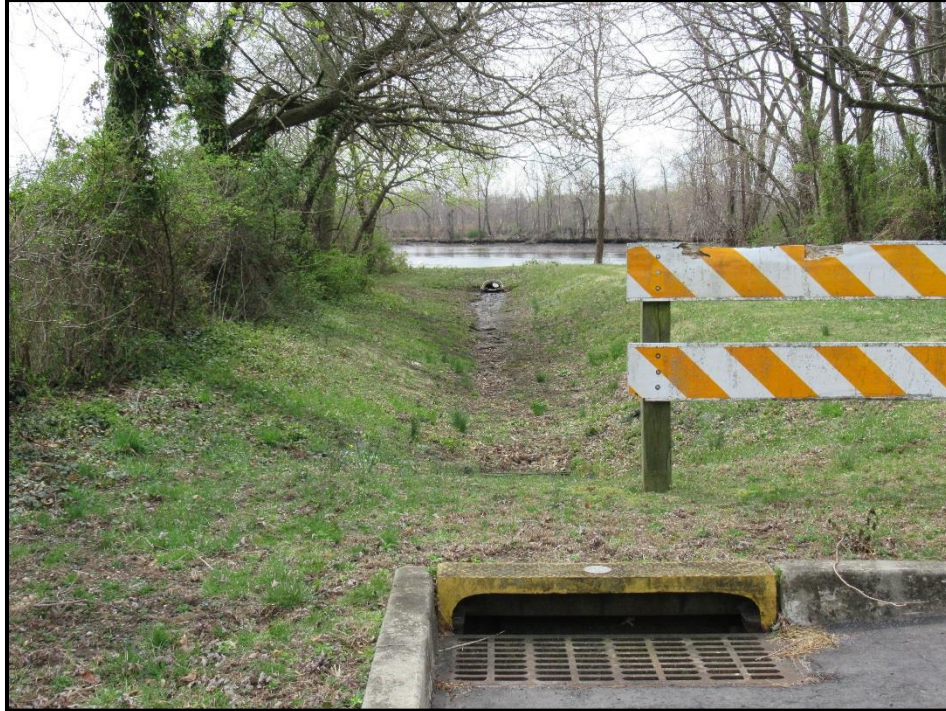
The Ash Street street-end is paved for approximately half the right-of-way length. The remaining portion of the street is unpaved and the location of a stormwater swale which extends the existing subsurface stormwater system to the Rancocas Creek, as pictured below.

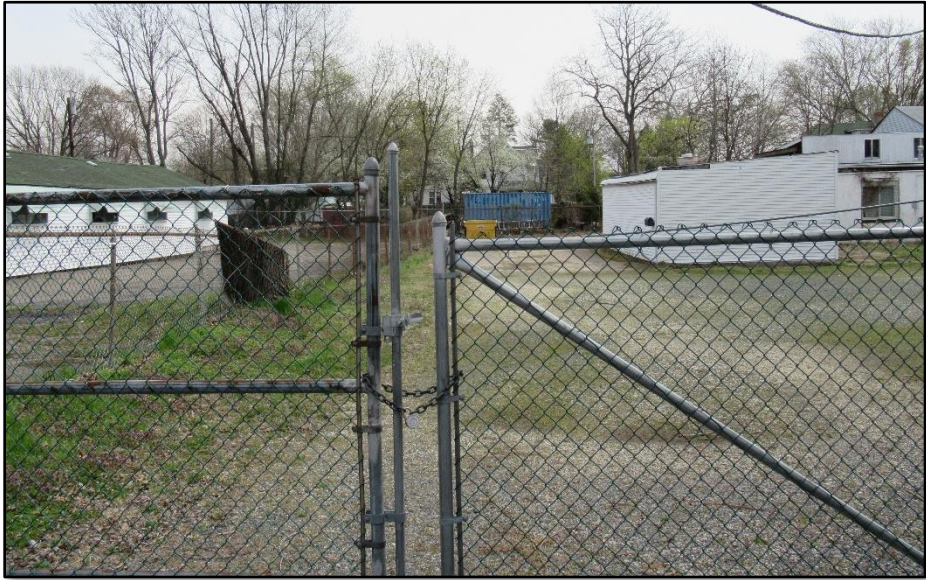
The following photo, taken from Ash Street and facing east, illustrates the relationship between the lots in Block 1411 which are separated by fences. Lot 1 is to the right of the image and 1.01 is to the left of the image. The blue shipping container in the background is located on Lot 2.

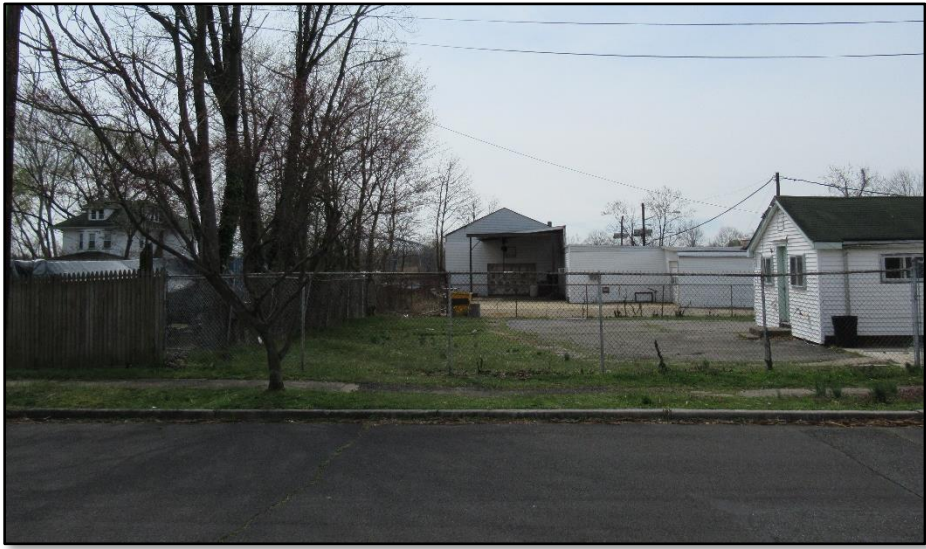
The following photo, taken from Rancocas Avenue and facing south (towards the Rancocas Creek), illustrates the relationship between the lots in Block 1411 which are separated by fences. Lot 1.01 is to the right of the image and Lot 2 is to the left of the image. The dwelling to the left and in the background is located on Lot 2.

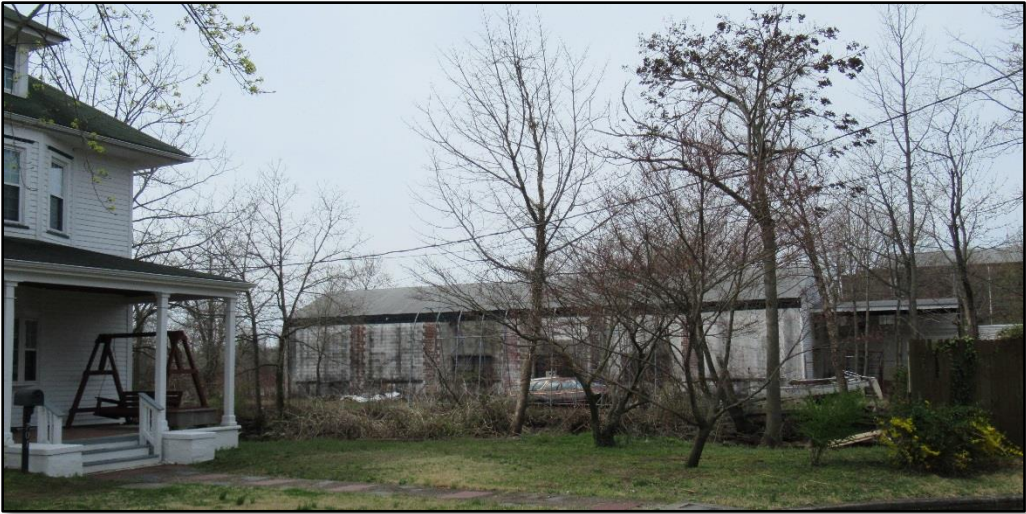
Block 1411, Lot 1

Block 1411, Lot 1, contains a sprawling, one-story frame structure with additions and overhangs at the G-O-Metric Inc. site. The site is fenced and contains indoor and outdoor storage, offices, and a boat launch. The most recent use for the building was a manufacturer of industrial supplies. The site is largely open and unimproved with gravel and stone, open circulation, storage, and parking areas. The following photo is taken from the end of Poplar Street at its intersection with Rancocas Avenue. The dwelling located on Lot 2 is in the foreground; and the building on Lot 1, adjacent to the Rancocas Creek is visible.

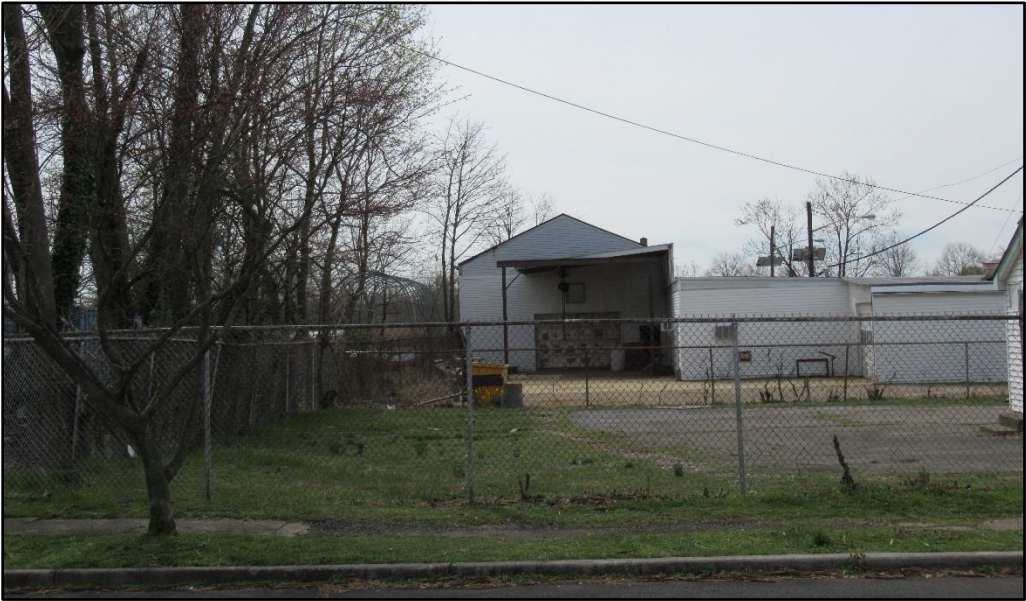
The image below is taken from Rancocas Avenue facing south through Lot 1.01 and into Lot 1.

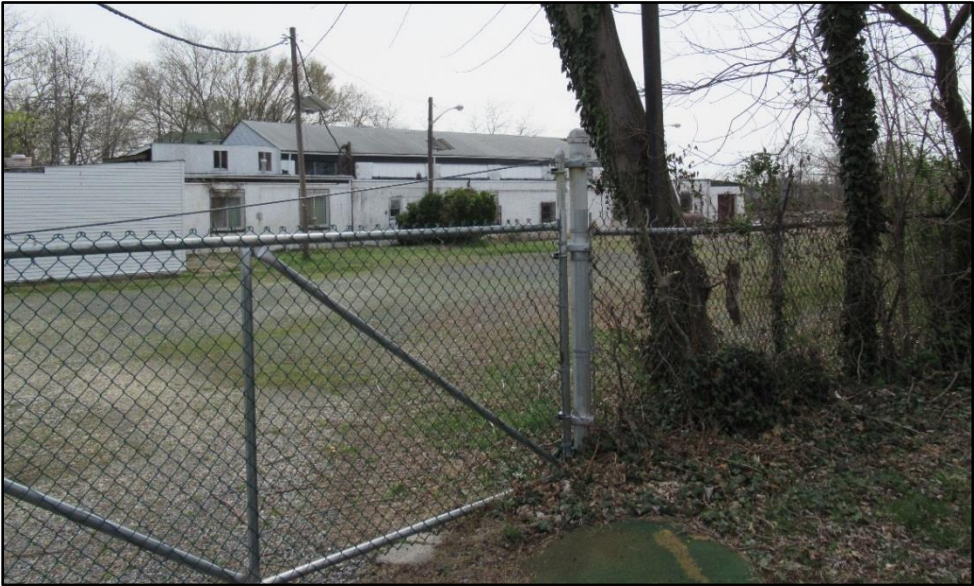
The images following are taken from the Ash Street street-end. The image below illustrates the existing building facing due southeast with the circulation, storage and parking area in the foreground.

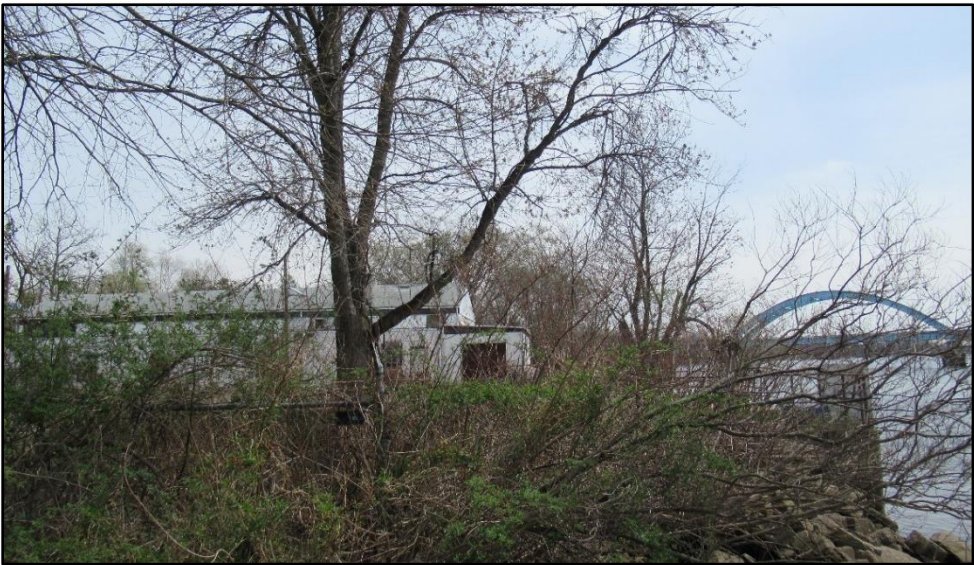
The photo below illustrates the existing building facing south, with the Rancocas Railroad Bridge and Rancocas Creek to the right side.

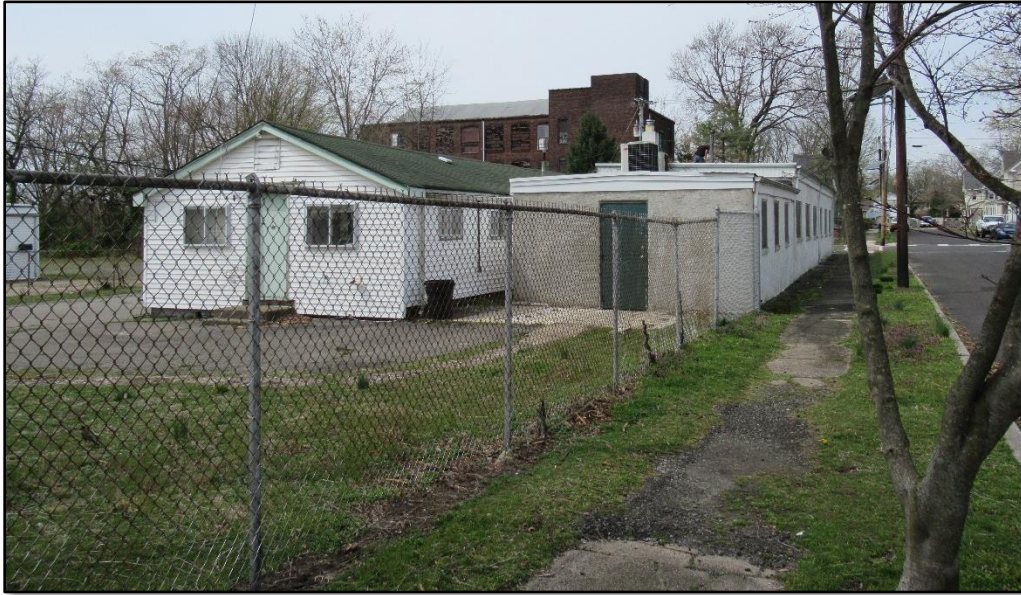
Block 1411, Lot 1.01

On Block 1411, Lot 1.01, observation shows two one-story frame structures as the Crownflex Abrasives site. The site is fenced and has been used for indoor and outdoor storage, offices, and manufacturing of industrial supplies.

The following photograph illustrates the site and buildings facing due west from Rancocas Avenue.

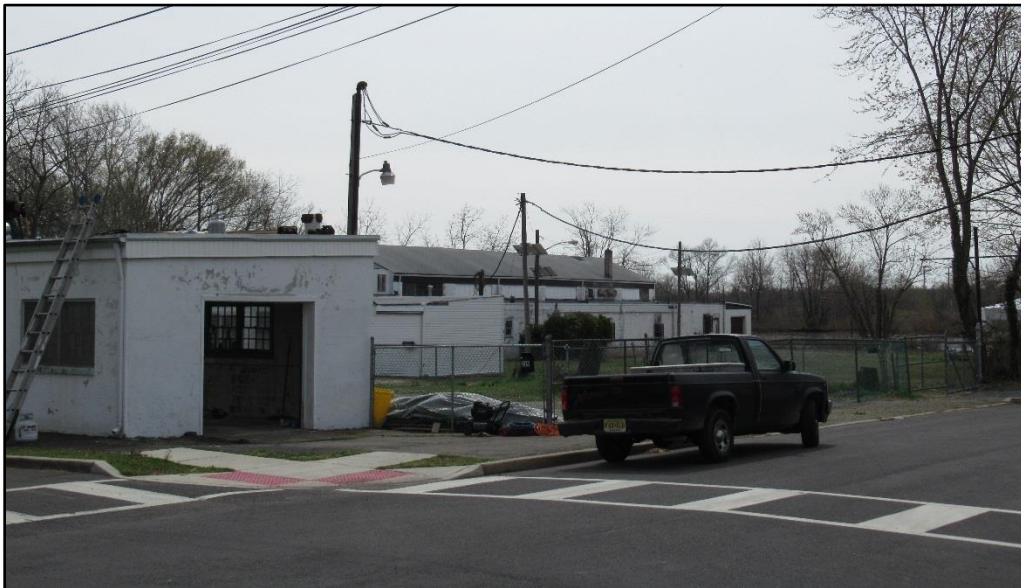
The image below is taken facing southeast from Rancocas Avenue. The roof of one of the buildings is being repaired.

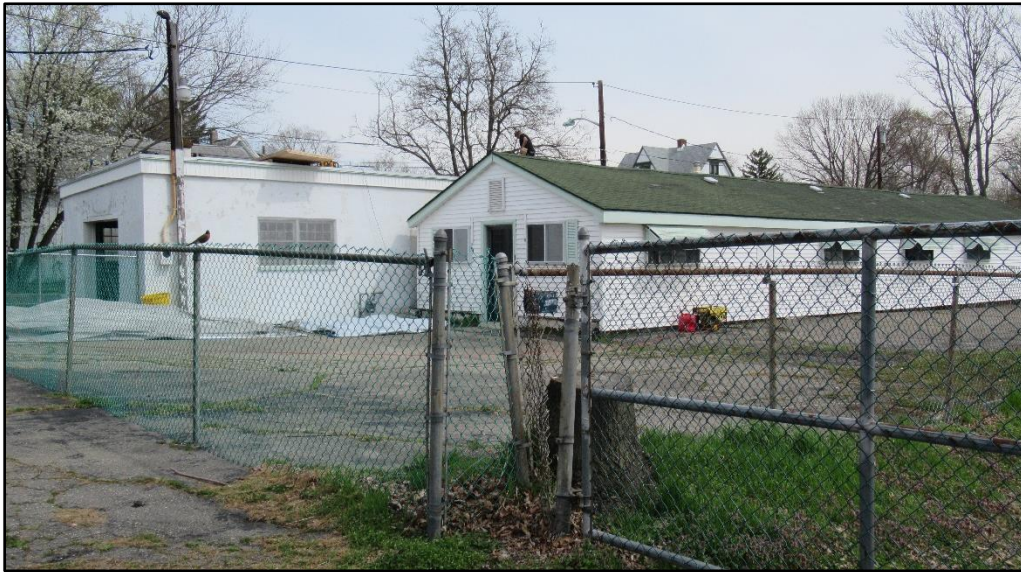
A view of the buildings facing northeast from the Ash Street street-end with the fence serving Lot 1 in the foreground.

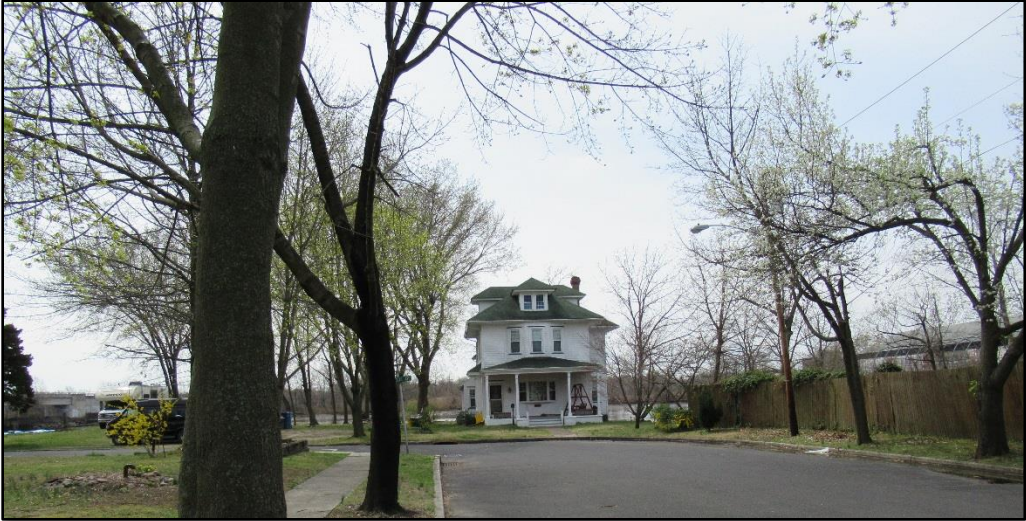
The dwelling on a portion of Lot 2 pursuant to the tax assessment records appears to be in good condition and well maintained. A portion of Lot 2 fronting along Rancocas Avenue and Poplar Street is surrounded by a wooden stockade fence. Based upon aerial images and site observation the lot contains boats and boat parts, deteriorating boat ramp/launch, unidentifiable materials covered by tarps and old tires, shipping container, vehicles, and shed(s).

The photo was from the intersection of Poplar Street and Rancocas Avenue facing south of the dwelling. The stockade fence lining the street and reducing visibility into the site is to the right.

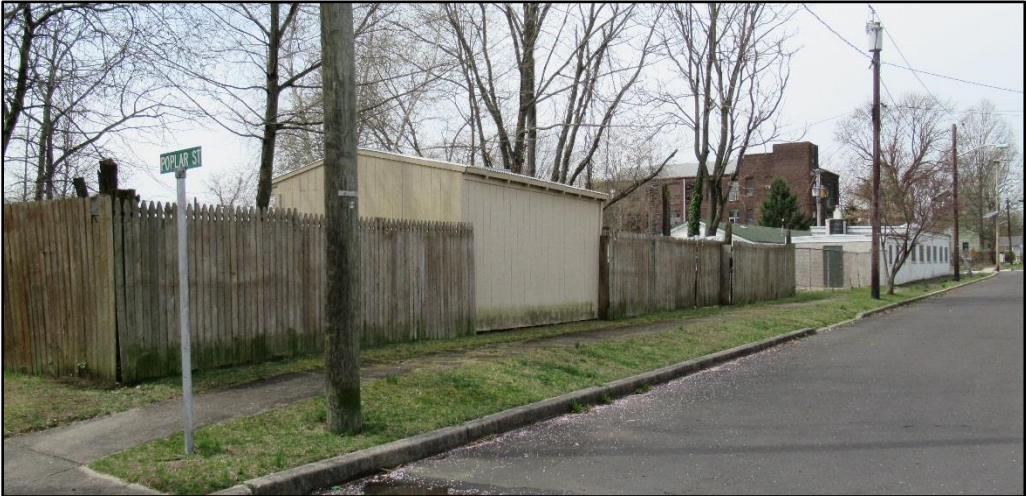
The following photo was taken facing southwest from the intersection of Poplar Street and Rancocas Avenue. A fence and large shed or garage are visible.

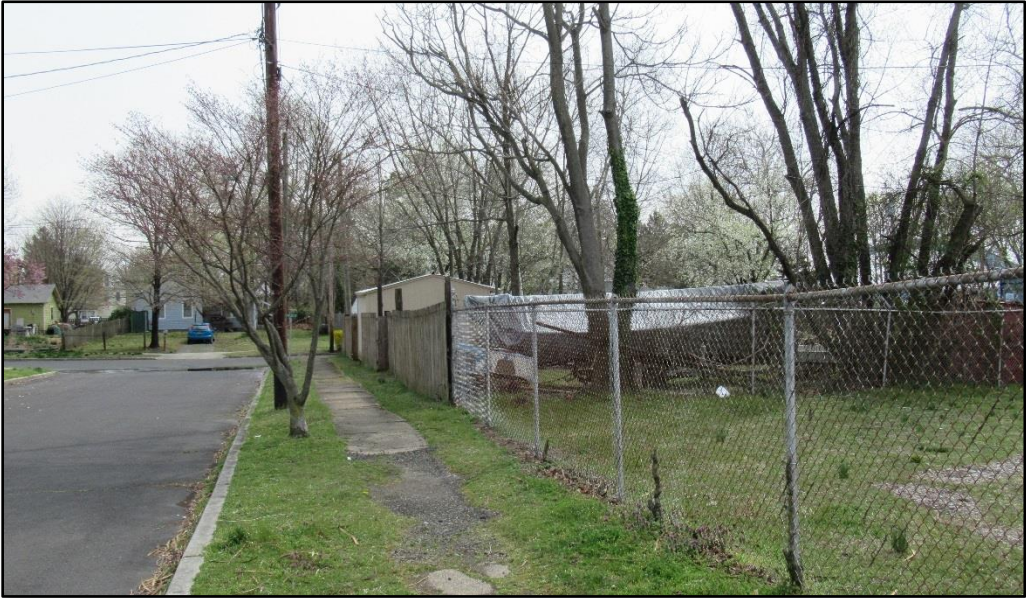
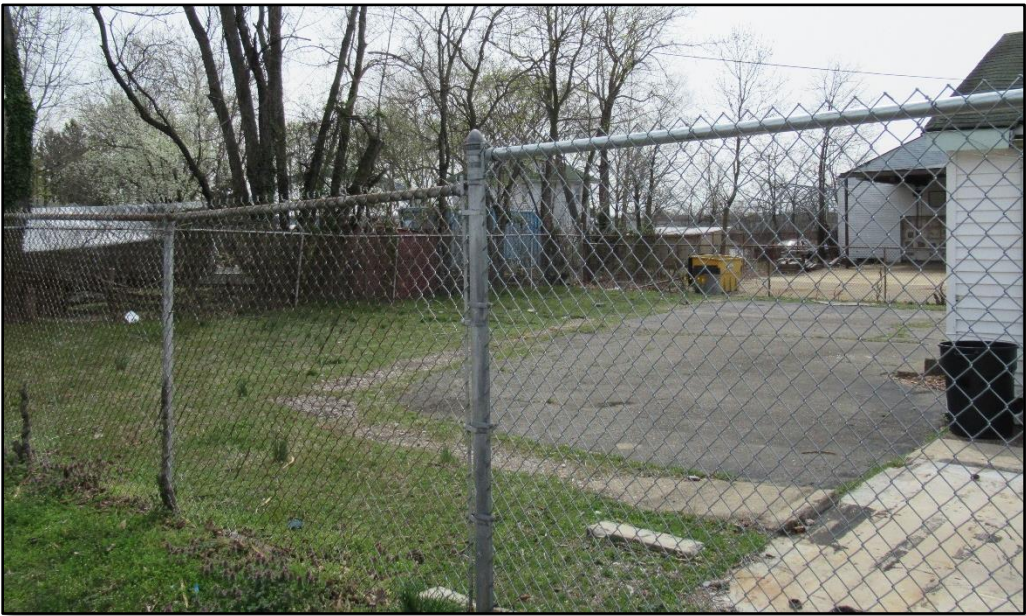
The following two photographs are taken from Rancocas Avenue and face southeast, illustrating covered boats, structures, and blue shipping container, on Lot 2.

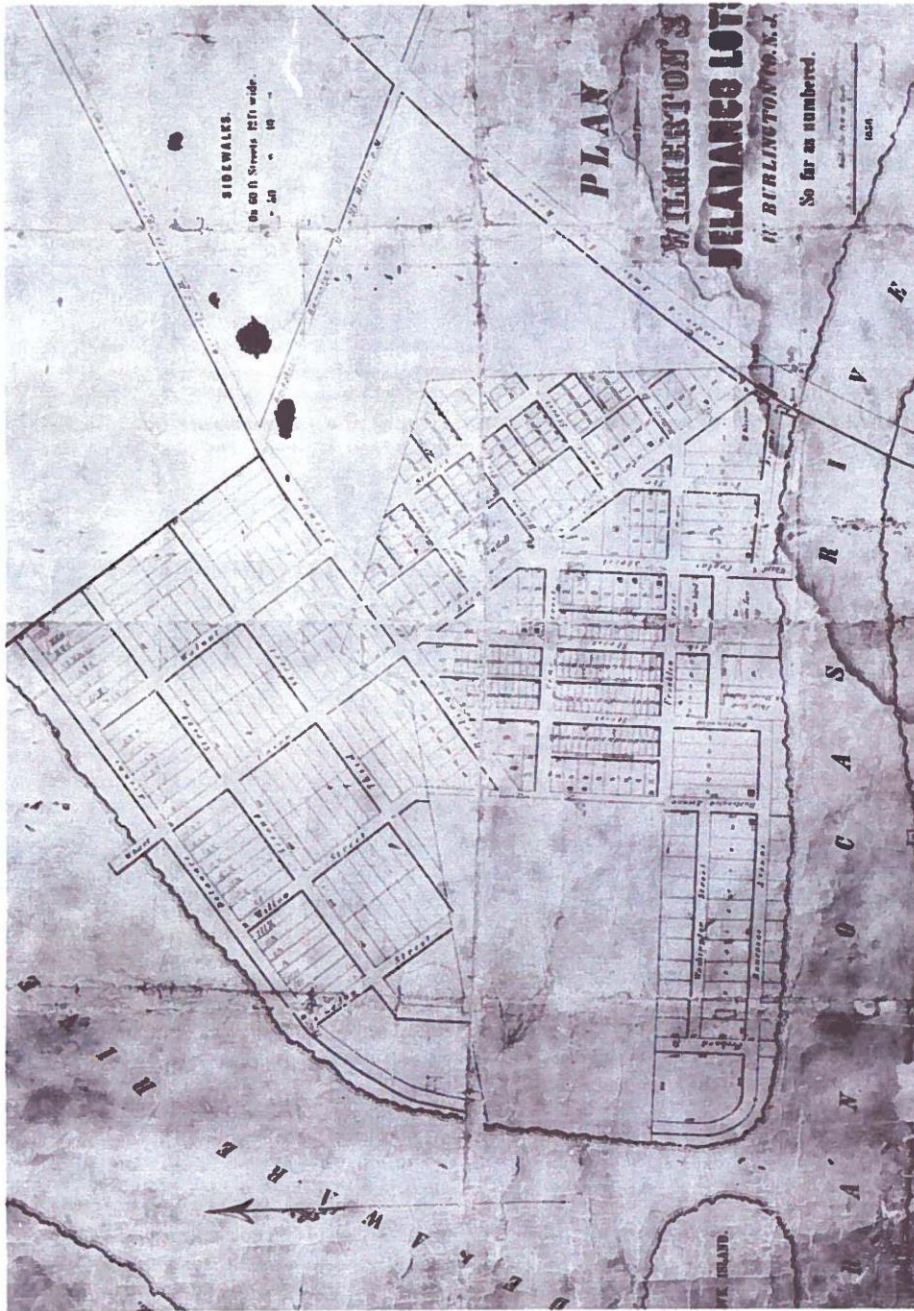
Appendix C- Historic Mapping – 1856, 1859, and 1876

the first homes were constructed. The upper part of the map shows earlier streets laid out between Burlington Avenue and the Delaware River. The first major developer in town was the Delanco Land Co. It was made up of Philadelphia investors.

THE SECOND MAJOR development in Delanco was "Wilmington's Delanco Lots" (the segment in the lower portion of the photograph), laid out in 1856 according to the date on the map. Although not visible in the reproduction shown here, the original map shows T3 black squares where

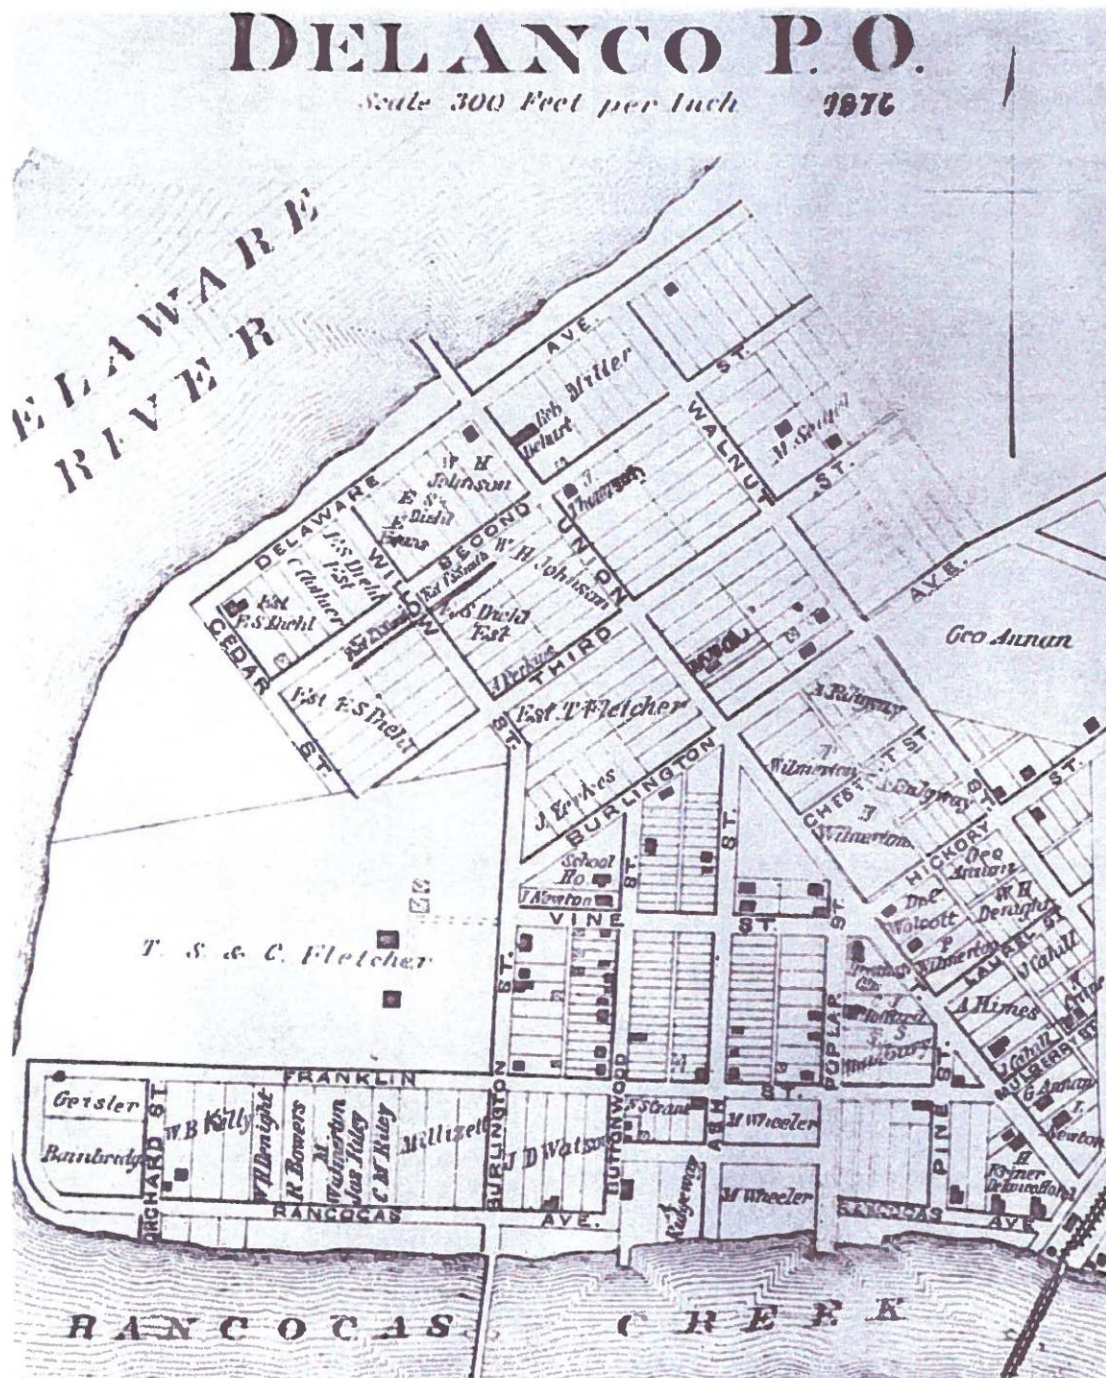
THIS MAP is dated 1876, the year of the nation's Centennial, and shows the location of the homes that were

standing in Delanco at the time. Hawk Island (not shown) is to the lower left.
